At your request, an inspection of the above property was performed at [The Nicest Street in Raynham MA](#) on [September 4th, 2011](#). Striler Home Inspections, Inc. is pleased to submit the enclosed report.

Inspection report for Sample Client - The Nicest Street - Raynham - MA

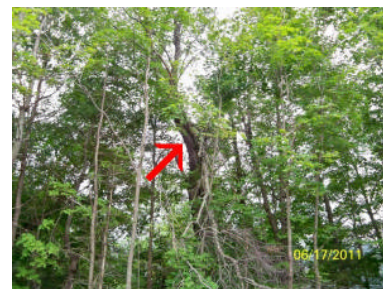
Tree(s) Condition:

- At least one tree on the site needs to be removed or have portions removed.

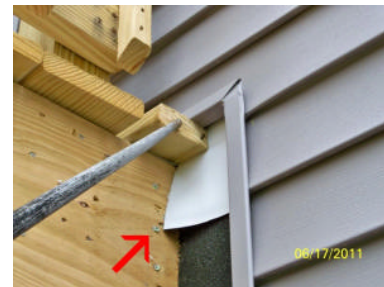
Exterior Walls Materials & Condition:

- **Problems were noted with the vinyl wall covering. Improper flashing was discovered at the left corner of the deck. In it's current condition, rain water will be allowed to get between the siding and the house wrap and potentially cause moisture damage. A qualified contractor should be called for an estimate to make repairs.**

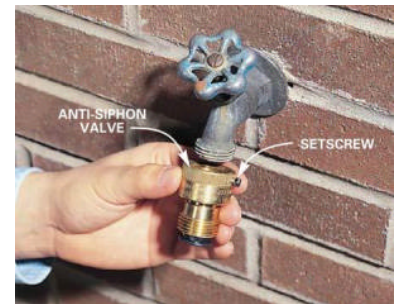
Hose Faucets**Operation:**

- Operated all exterior faucets, appear serviceable.
- **Recommend installing Anti-siphoning device at all exterior faucets to prevent potential contamination of potable water in home.**

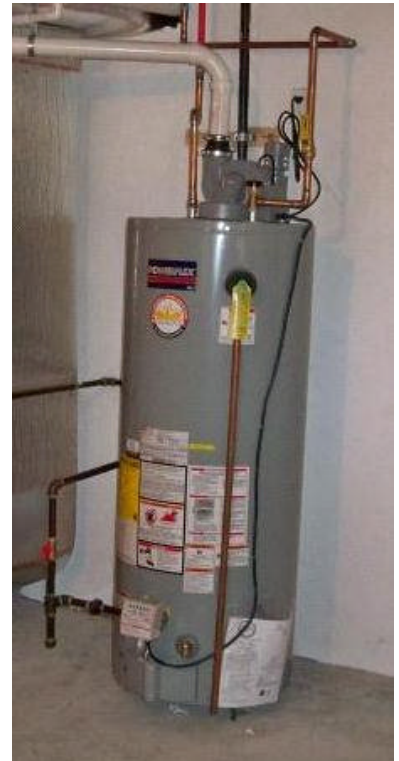
**Water Heater****Type:**

- The water heater is gas.

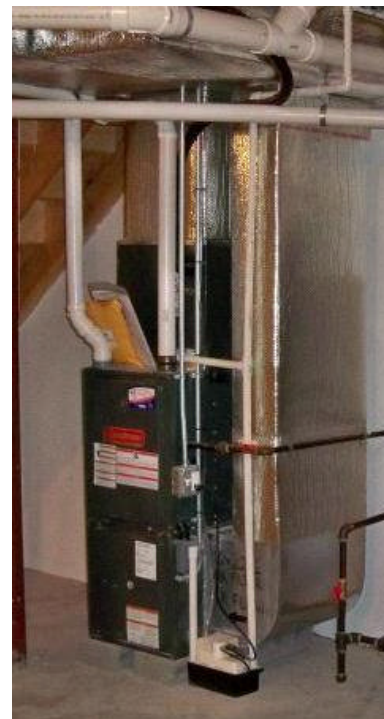
Type & Location:

- The heating system is located in the basement.
- The heating system is a forced air system.
- The furnace is a newer high efficiency type with a fan installed in the vent pipe to push the burnt flue gases up and out the flue.

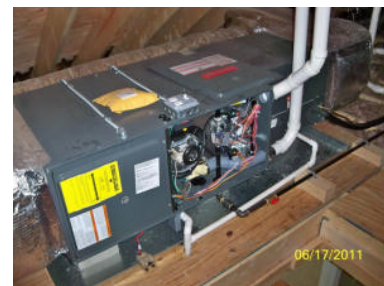
Air Conditioning Unit**Type:**

- Central.

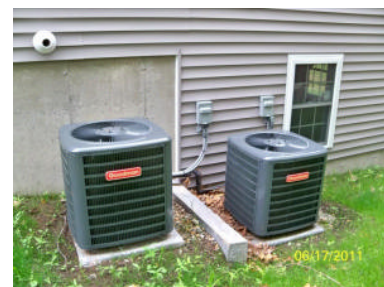
**Condenser Location:**

- The AC condenser is located on the right side of the house.

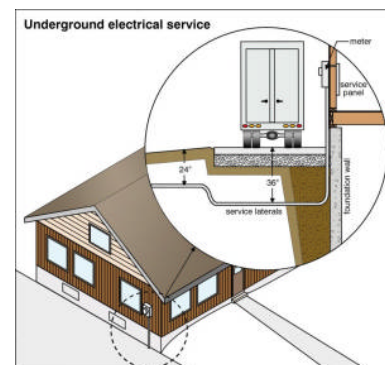
Service Entrance / Meter:

- The electrical service enters the building underground. Underground service to the structure is desirable for safety and appearance. Note: If any excavation is planned in the future be sure to contact the utility company to mark the location of underground cable before digging.

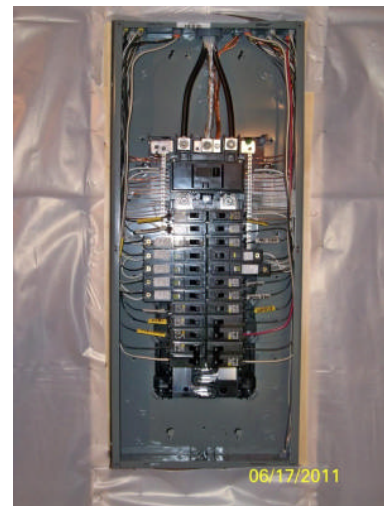
Main Panel Type:

- The structure is equipped with a breaker type main power panel. This is the desirable type; when a breaker trips off, it can easily be reset. Caution: If a breaker is reset and trips back off, this is an indication that there is a short or weakened condition in the circuit. Call a qualified licensed electrician for analysis of the existing problem.

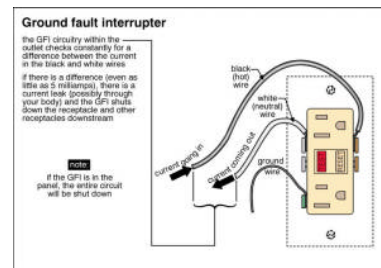
Ground Fault Protected Outlets:

- This structure is adequately protected by using Ground Fault Circuit Interrupt outlets at all locations within 6' of a water source and any of these locations: all outside outlets, in the garage, and in an unfinished basement.
